**Flood Control Project Maintenance
Levee Inspections**

Maintenance Issue Types Only, Levee Inspection Report By Mile - Spring 2019

California Department of Fish and Game Shea Levee

Waterway	Bank	Unit Miles	Inspection Start/End	Inspector
Unit No. 01 Sacramento River	Left	0.30	03/29/2019 03/29/2019	Makar Sokol

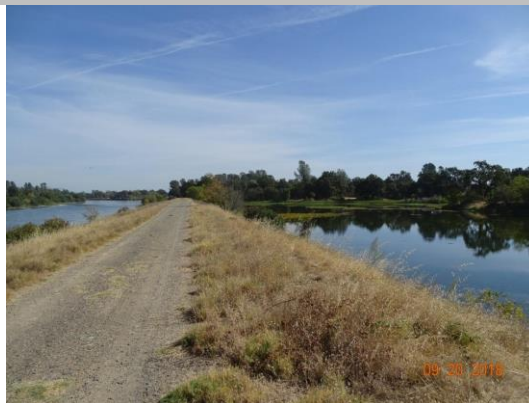
Photo 1 of 3 : SP_2019_NA0018_269_2_20190325_00003.jpg

LM Start	0.00	Rating **	M	Issue No.	2
LM End	0.30	Issue Type +	Ma	Location *	LS
Category	Earthen Levee			GPS Latitude/Longitude	
				Start	End
Item	Vegetation			40.507697 °	40.511210 °
				-122.363683 °	-122.360390 °
DWR ID	DWR_NA0018_01_s_2012_2				
Comment Code					
V2 : Remove the wild growth other than native grasses from the levee slopes.					
Inspector Comment

View of the vegetation along the landside slope.

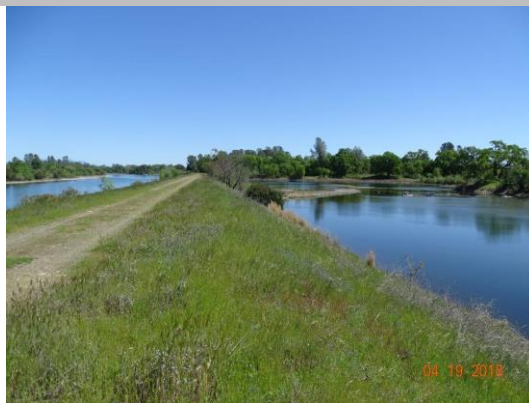
Photo 2 of 3 : SP_2019_NA0018_269_2_20190325_00004.jpg

View of the vegetation along the landside slope.

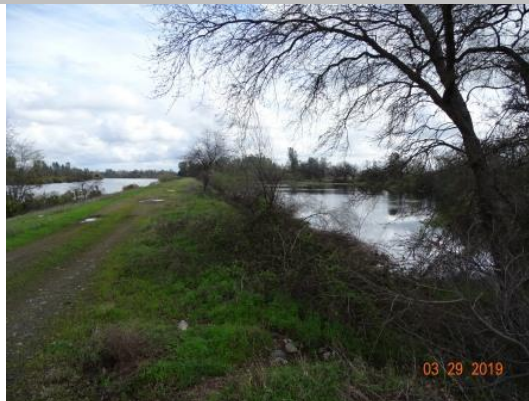
Photo 3 of 3 : SP_2019_NA0018_269_2_20190405_00008.jpg

View of the wild growth along the landside slope.

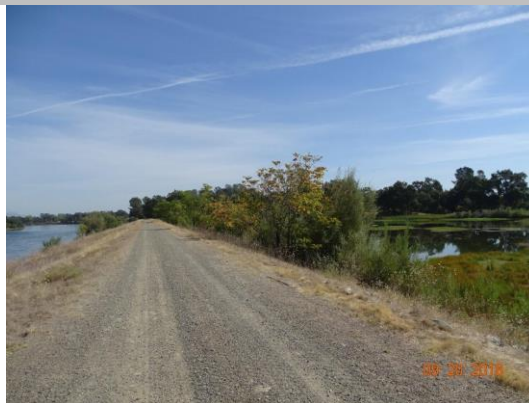
Photo 1 of 1 : SP_2019_NA0018_269_3_20190325_00005.jpg

LM Start	0.00	Rating **	M	Issue No.	3
LM End	0.30	Issue Type +	Ma	Location *	LS
Category	Earthen Levee			GPS Latitude/Longitude	
				Start	End
Item	Trim / Thin Trees			40.507738 °	40.511210 °
				-122.363682 °	-122.360390 °
DWR ID	DWR_NA0018_01_f_2017_3				
Comment Code					
T3 : Trim and thin trees to allow visibility of the ground and room to flood fight.					
Inspector Comment

View of the trees along the landside slope.

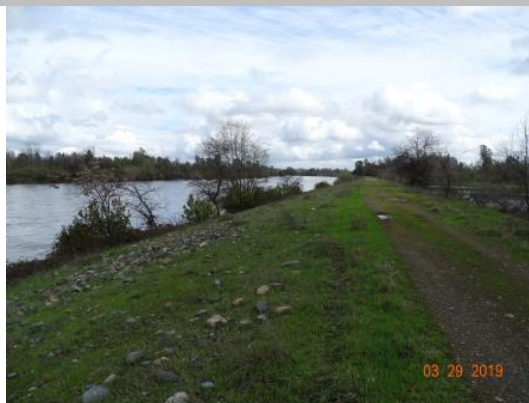
Photo 1 of 1 : SP_2019_NA0018_269_1_20190404_00007.jpg

LM Start	0.00	Rating **	M	Issue No.	1
LM End	0.30	Issue Type +	Ma	Location *	WS
Category	Earthen Levee			GPS Latitude/Longitude	
				Start	End
Item	Vegetation			40.507697 °	40.510670 °
				-122.363683 °	-122.361203 °
DWR ID	DWR_NA0018_01_s_2012_1				
Comment Code					
V2 : Remove the wild growth other than native grasses from the levee slopes.					
Inspector Comment

View of the vegetation and wild growth along the waterside slope.

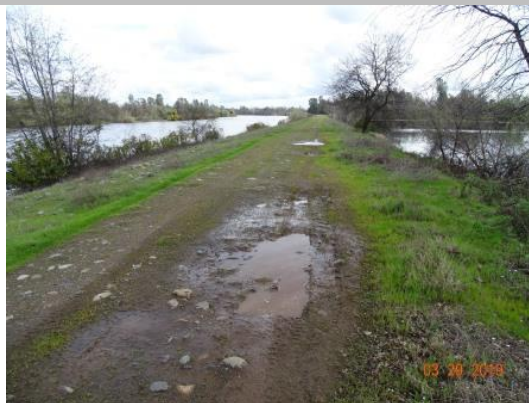
Photo 1 of 1 : SP_2019_NA0018_269_4_20190404_00006.jpg

LM Start	0.05	Rating **	M	Issue No.	4
LM End	0.05	Issue Type +	Ma	Location *	CR
Category	Earthen Levee			GPS Latitude/Longitude	
				Start	End
Item	Crown Surface / Depressions / Rutting			40.508401 °	40.508401 °
				-122.363261 °	-122.363261 °
DWR ID	DWR_NA0018_01_s_2019_4				
Comment Code					
C3 : Add appropriate gravel or road base. Grade and compact.					
Inspector Comment

View of the crown surface with depressions and no gravel.
